Appendix C

Audited CP Solutions Photos

Ma An Shan – Shan Ying Mill

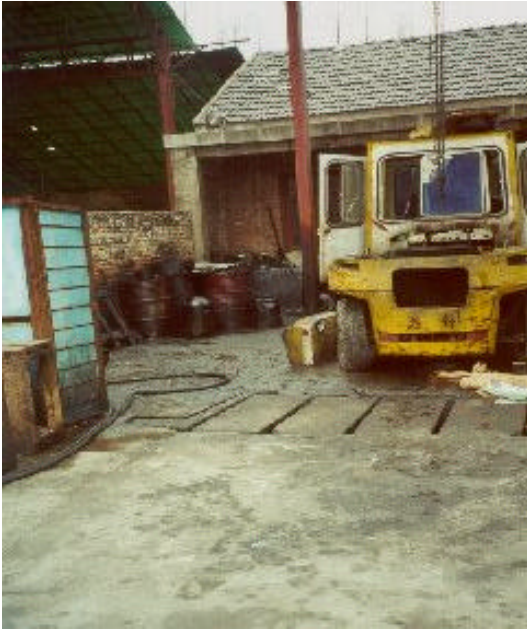
Photo 1: Hydraulic oil recovery

This picture shows the hydraulic oil recovery drums (in the background) and the mill's sewer (in the front) where hydraulic oil was disposed of before the implementation of this solution.

CP Solution #4

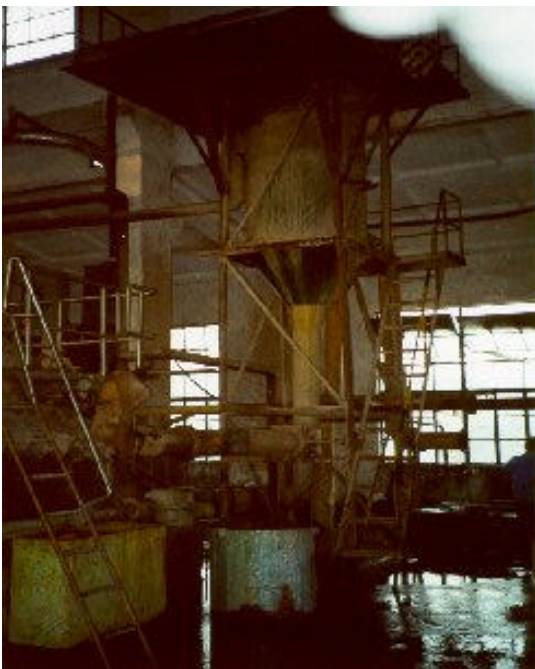
Photo 2: Starch and polymer dosing equipment

Ma An Shan-Shan Ying mill is now adding some starch and polymer to the wet end of their paper machines. This solution allows the mill to reduce its fiber consumption and to increase the quality of its products. Photo 2 shows the starch and polymer dosing equipment.

CP Solution #5
